Chapel of St Luke, Royal Hospital Haslar, Gosport

RCHME Level 3 Building Report

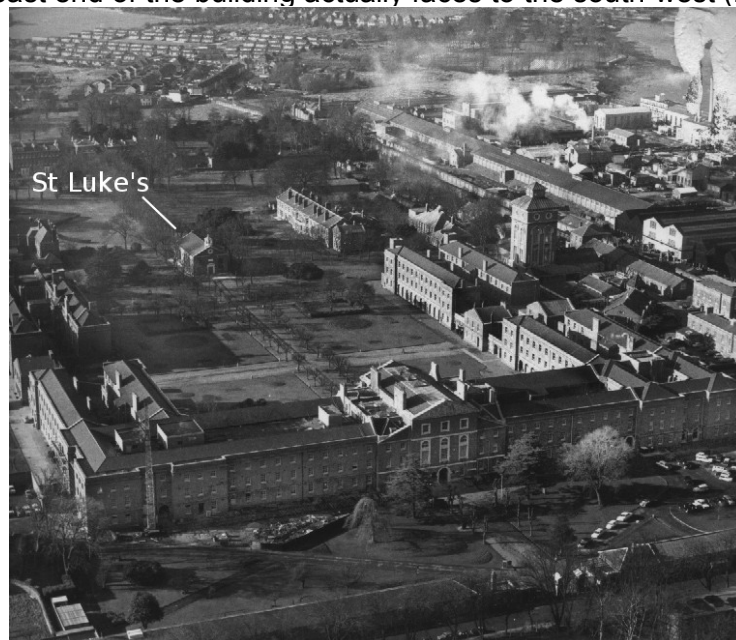
Figure 3: Aerial view of Hospital looking west

The building is situated on level ground slightly elevated compared to the remainder of the hospital. It takes its alignment from the major axis of the rest of the hospital as shown in an aerial photograph (Figure 3) taken around 1970. This means the ecclesiastical east end of the building actually faces to the south-west (Figure 4).

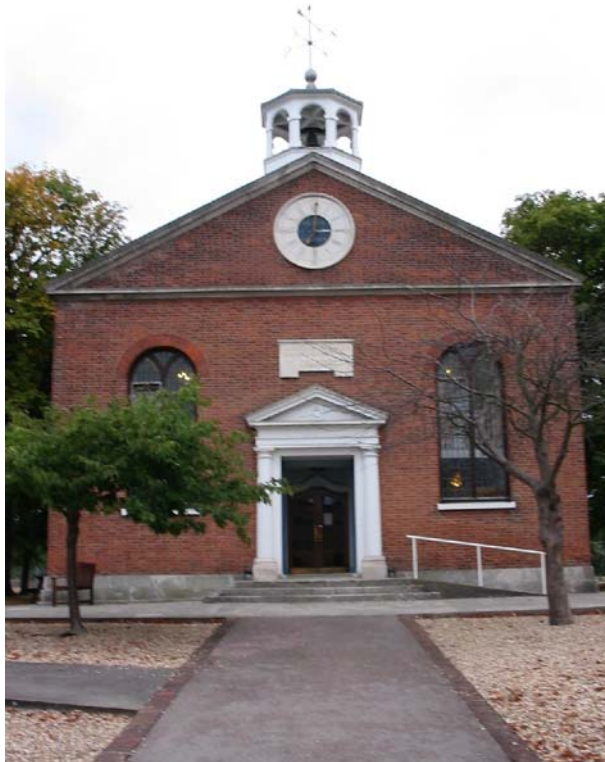
Figure 5: North-East elevation - photograph

The main entrance is on the north-east elevation - the ecclesiastical west end (Figure 5 and 10). This comprises an entrance porch within the thickness of the wall flanked by windows with a simple wooden 'Y' tracery frame and small, rectangular panes of clear glass in lead surrounds. The windowsill is of white stone and the round head of the window is surrounded by rubbed brick headers.

The pediment of the porch is supported on half Tuscan pillars which are applied to the adjacent brickwork. Above the pediment a stone panel has the date MDCCLXII (1762) and carries the text, in Latin, of Matthew 25, verse 40.

The clock inserted in the oculus above the horizontal stone pediment carries the inscription 'Colley London'. There is an octagonal bellcote and weathervane at the north-east end of the main roof ridge.

In front of the door is a small stone platform approached by 3 steps; a concrete access ramp has been added to the north-west side of the steps.

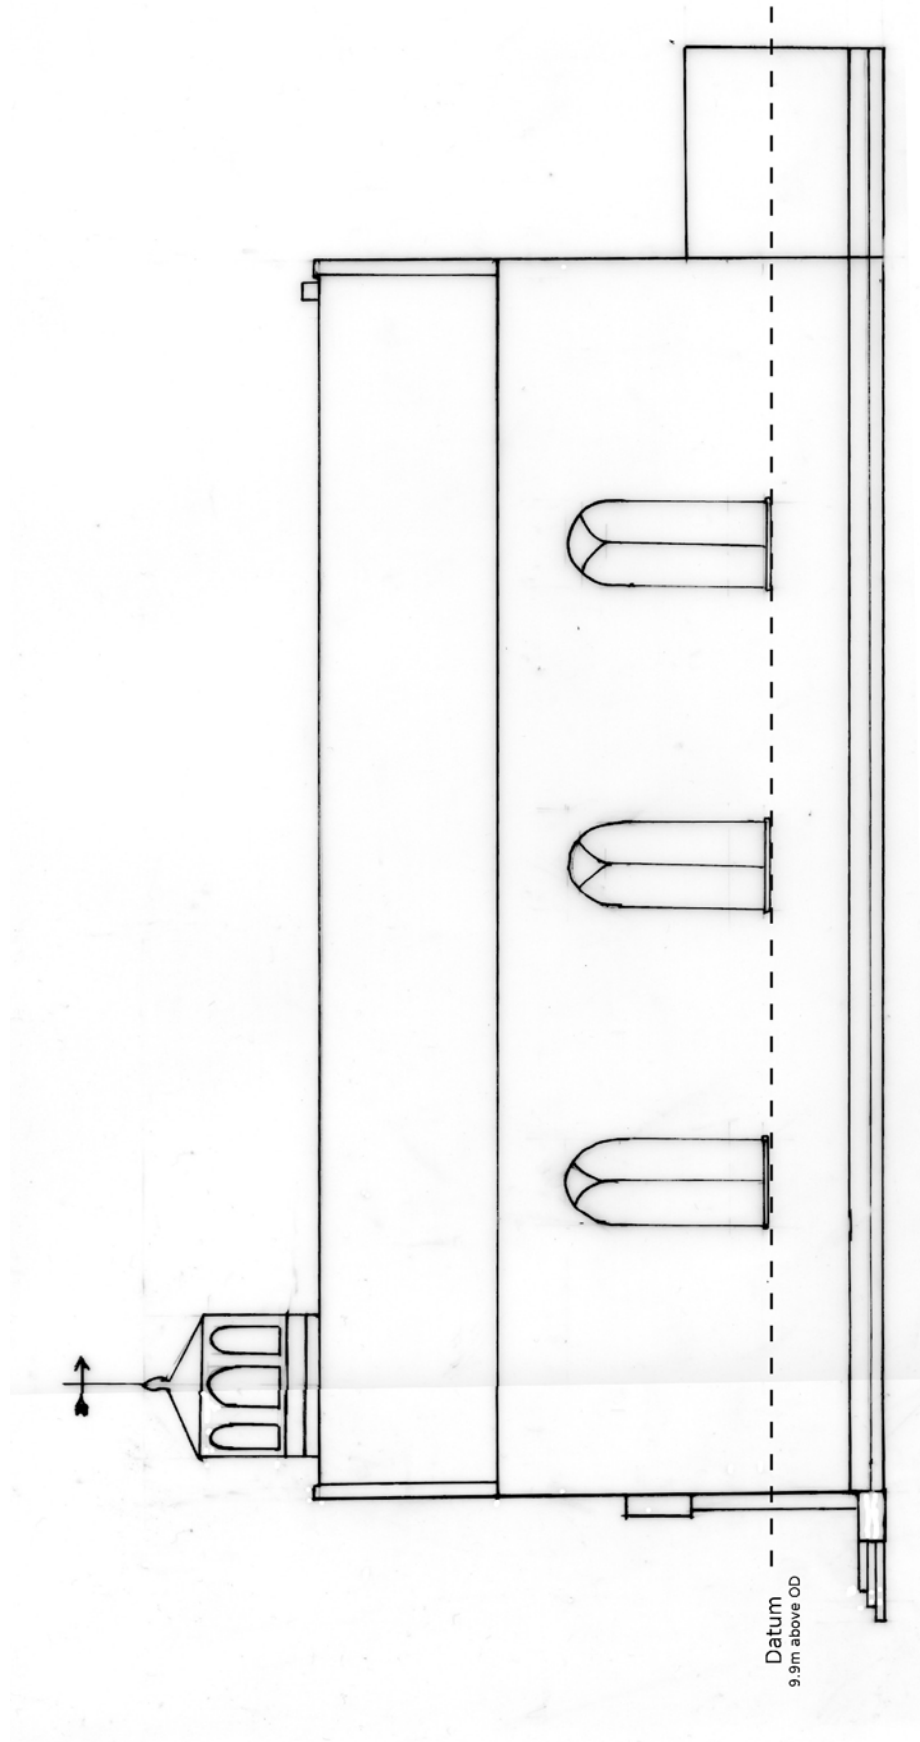
Figure 7: North West elevation - scale drawing

The North-West and South East elevations are identical and form the long axis of the building (Figure 6 and 7). The base of both the main body of the building and the single storey extension is formed by the stepped stone plinth. There are three identical round headed windows on each elevation identical to those on the north-east elevation. The windows on each side at the south-west end are stained glass images from the New Testament and are dated 1912 (south-east elevation) and 1916 (north-west elevation) and commemorate those Royal Naval and Royal Marines who died in the hospital. The remaining two windows on each side are clear.

The single storey extension at the south-west end is stepped in slightly from the main building. The brick courses between these two elements align precisely, the actual join is obscured by rainwater downpipes and it is impossible to determine if the brick sections are 'keyed' together or if the extension is 'applied' to the main body.

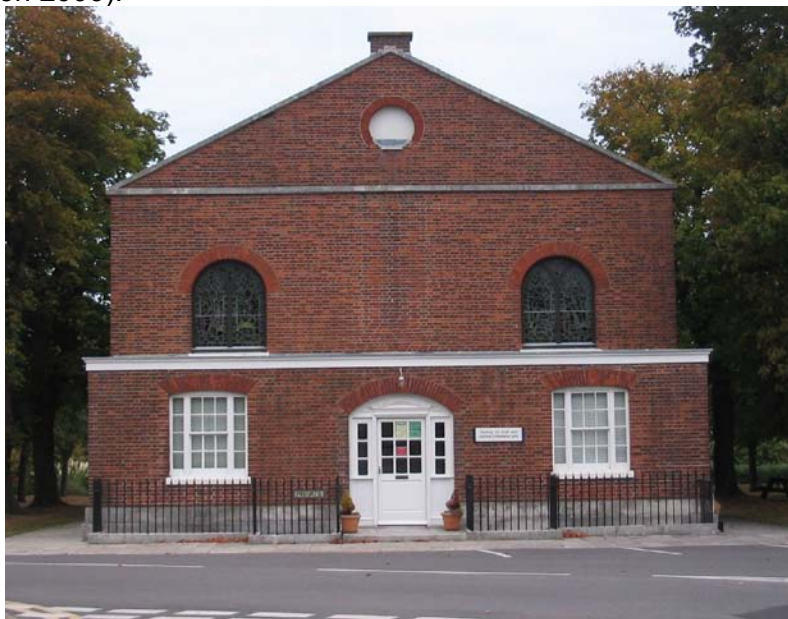
Figure 8: South-West elevation - photograph

The south-west elevation comprises the Chaplain's and Verger's offices that make up the single storey extension (Figure 8 and 9). The two windows in the main body of the building are the same width and height as the windows previously described but their base is truncated because of the office extension.

A pattern in the brick, extending from a small chimney at the roof apex, appears to outline a flue that lies within the thickness of the wall. There are no internal fireplaces or boilers associated with this flue (see Documentary Evidence).

To the south-east steps lead down to the crypt. This extends under the whole of the office extension and approximately 2m of the main body of the chapel (Smith, personal communication 2006).

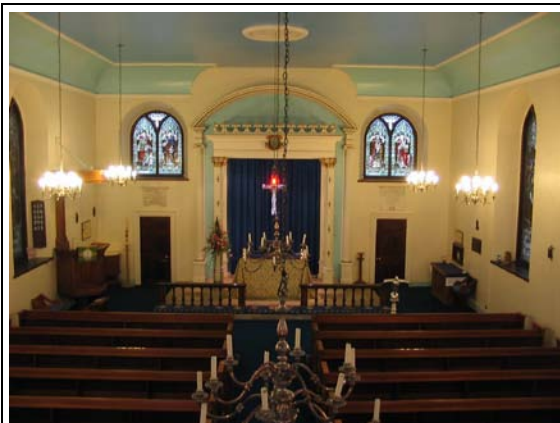
Figure 11: Interior view of south-west elevation and alter

The body of the Chapel is a single space with the pews facing the alter and pulpit at the south-west end (Figure 14). The alter is on a stepped platform under a baldachino (canopy) supported on decorated Ionic columns (Figure 11). The platform is formed from undressed regular stone slabs of similar dimensions to those that surround the outside of the Chapel. The remainder of the floor is modern woodblock laid in a herringbone pattern.

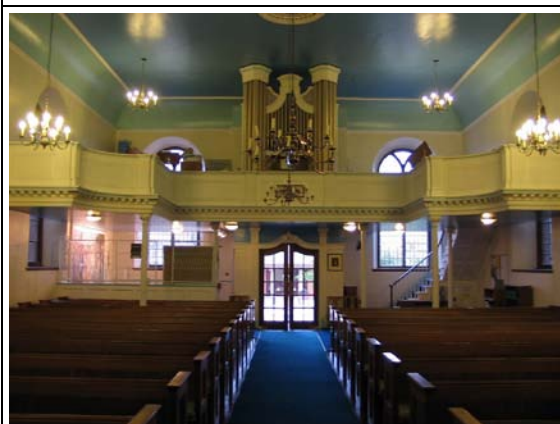
Figure 12: Interior view of north-east elevation

The gallery at the north-east end houses the organ and is approached by a single set of stairs (Figure 15). The gallery is fronted by painted wooden panels surrounded by a geometric carved border. The gallery is supported on slender painted metal columns(Figure 12).

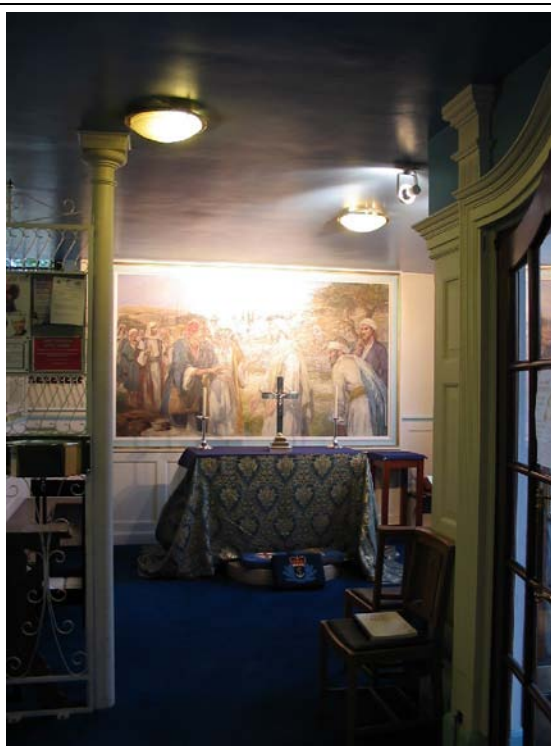
Figure 13: Baptistry in north-west corner

The North-West corner of the Chapel is partly partitioned from the main body and forms a small Baptistry with a small platform for the font. The font has been moved to the south-west corner and this area is now used as a private chapel (Figure 13).

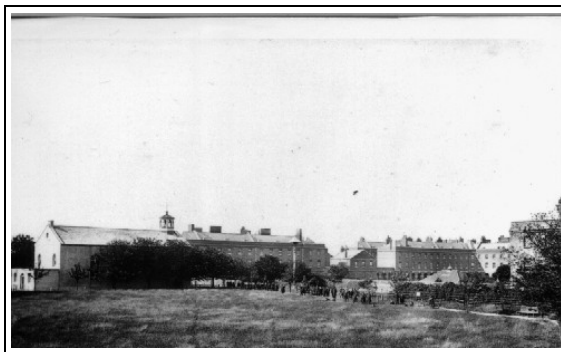
Figure 16: South-East Elevation before 1858

Figure 16, because of the absence of the water tower in the background, must be earlier than 1858 and Figure 17, because of the railings, must have been taken before 1908 when the railings were removed. From the height of the adjacent trees the images were probably taken at the same time. Both photographs show the 'Roman cement' rendering described by Sleight. There are no records of when the cement render was removed but an photographs of the Chapel before the restoration in 1963 show no evidence of cement render.

Early photographs (Figure 16 and 17) clearly show that at some point before 1858 the whole of the outside was covered in cement render; none of this render is now visible. There is no documentary evidence as to when this was applied but it is unlikely to have been part of the original construction phase in 1762. This is because the, now visible brickwork, is Flemish bond which uses more bricks than equally strong but less decorative alternative bond patterns. If the original intent was to conceal the bricks with render it would make no sense to use more bricks than necessary. This is particularly important as there was a shortage of funds at this time which meant that the fourth side of the main hospital complex was never completed. There are several directives from the Admiralty to the architect, not to spend any money on unnecessary decoration.

The Hampshire SMR states that the single storey extension on the south-west elevation is an early 20th century addition that partly obscures the windows in the ecclesiastical east end of the chapel. This is clearly incorrect as Figure 16, which was taken before 1858, clearly shows the current extension. Furthermore the stone pediment extends uninterrupted around the whole structure, the bricks are of an identical size and colour throughout and all the courses line up exactly. There are no 'scars' on the brickwork under the windows in the 'east' end to indicate they have been truncated. It is, therefore, most probable that the current external appearance of the building is as it was originally built and that there are no later additions.
